## **EXCLUSIONARY FENCING**

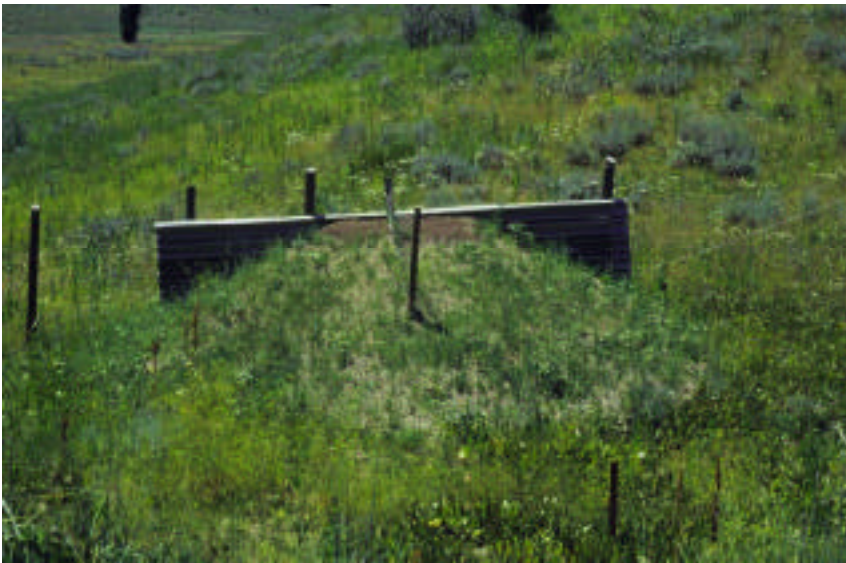
**FIGURE 2** Example earthen escape ramp (19).

In the late 1990s the use of one-way gates by deer was compared to that of an earthen escape ramp design (See figure 2) (19). There was some concern that the one-way gates (See Figure 1) were not really designed well for deer, and that they were reluctant to use them (19). Earthen escape ramps are simply piles of dirt covered with natural vegetation against a wall that is installed along the exclusionary fence. It is suggested the ramp height be 4.9 feet (1.5 meters), and that the exclusionary fence be lowered to that level when adjacent to the ramp (19). The deer use these ramps to escape the roadway right-of-way, and do not appear to have a problem jumping down from this 4.9-foot height (19).

A study in Utah compared the use of 16 earthen ramps to 18 one-way gates (19). In 1997, nine ramps were installed along United States 91, and in 1998 seven ramps were properly constructed along United States 40 (19). There were also 10 and 8 one-way gates, respectively, within each of these 1.5-mile roadway segments (19). Only about 33 and 49 percent of the deer approaching the gates on each roadway segment, respectively, actually used them (19). In addition, a standardized index of ramp and gate use was developed and it was found that overall the earthen escape ramps were used 8 to 11 times more than the one-way gates (19). The observed amount of deer mortality also decreased along United States 91 after the ramps were installed (19).
